MEMORANDUM
VIRGINIA DEPARTMENT OF ENVIRONMENTAL QUALITY
NORTHERN REGIONAL OFFICE

SUBJECT: Dominion – Possum Point Power Station VA0002071

DATE: April 15, 2014

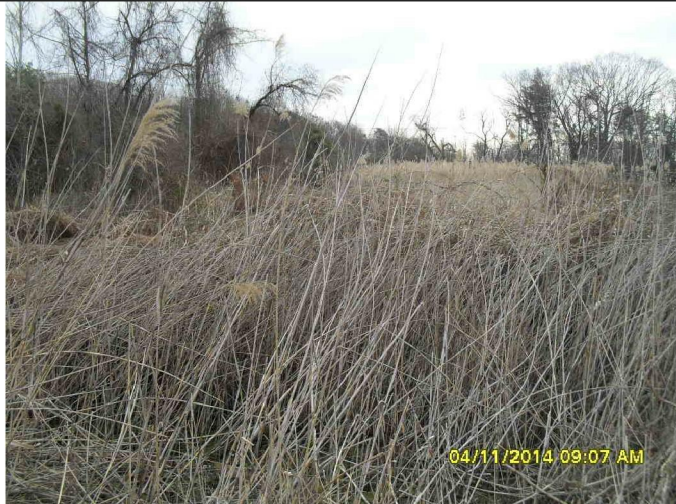
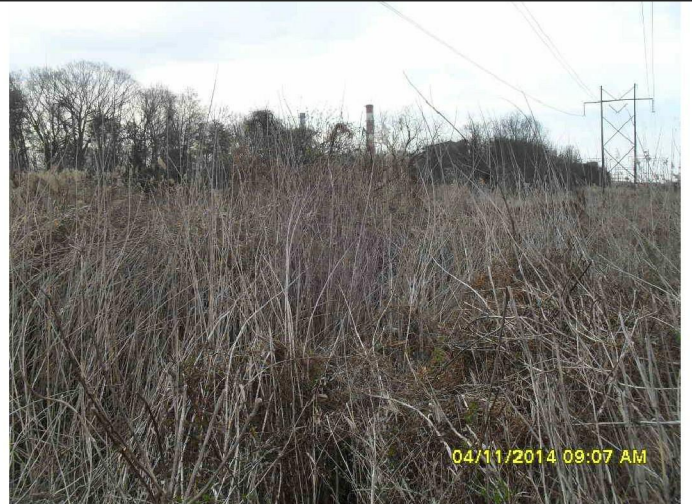
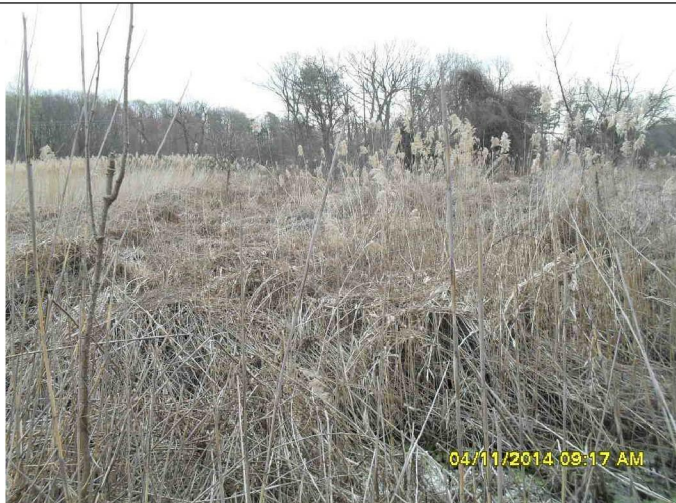
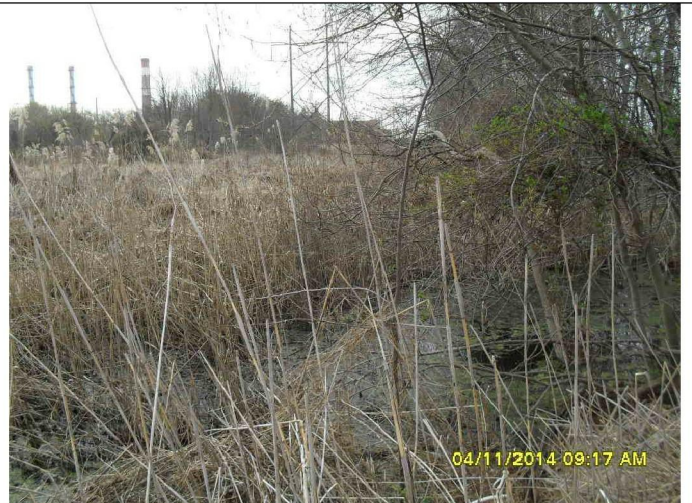
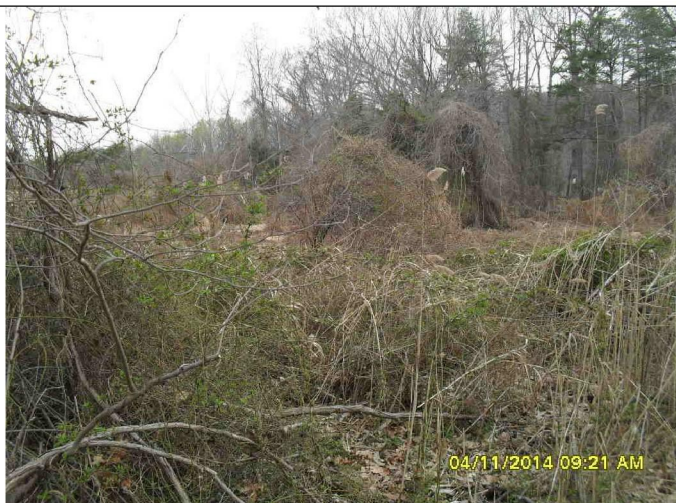
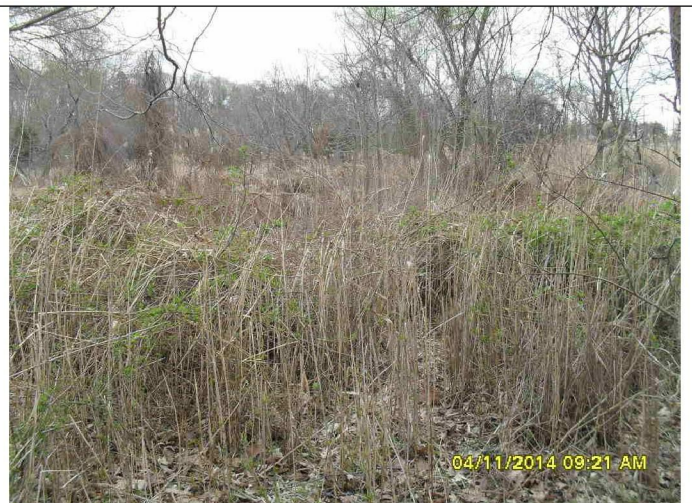
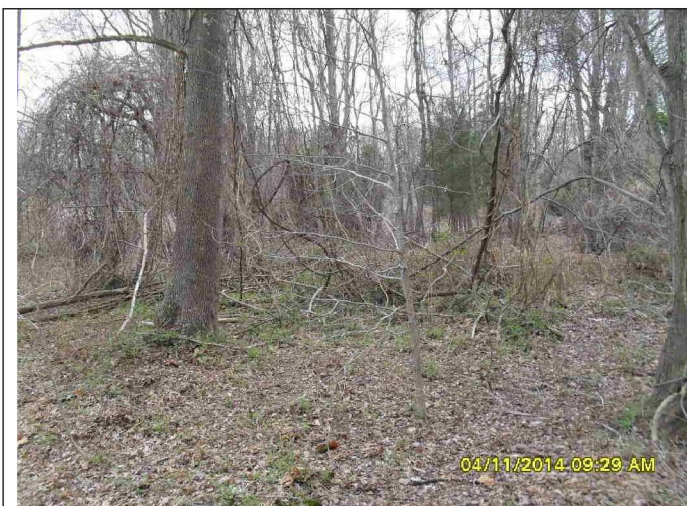
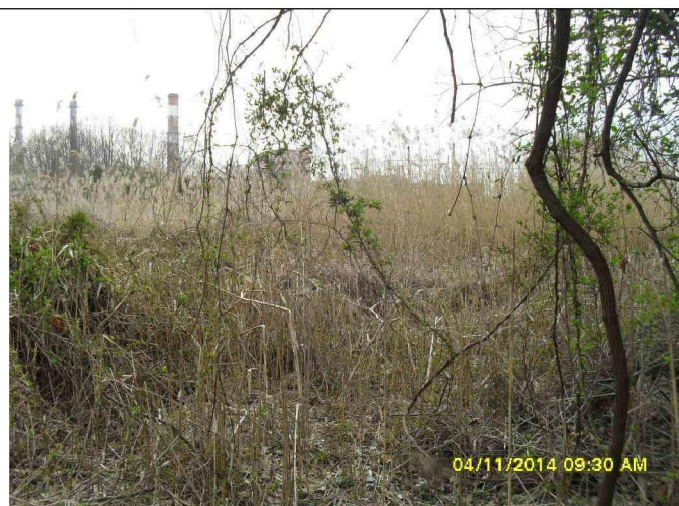
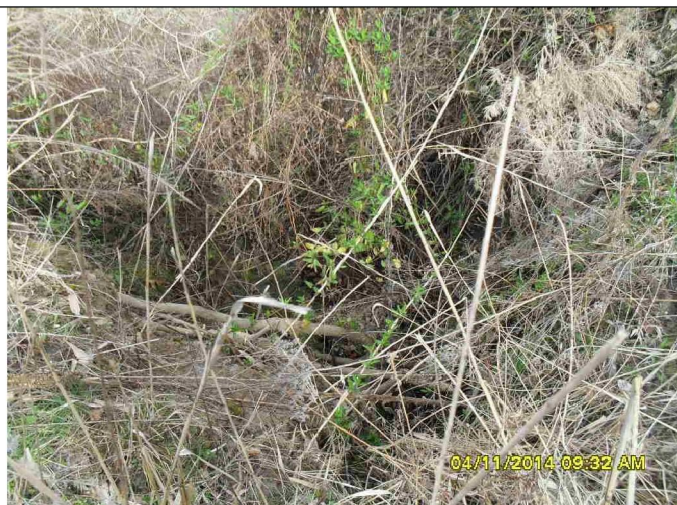
- Staff from the U.S. Army Corps of Engineers has been contacted concerning a wetlands determination.
- Ash Ponds A, B, and C are overgrown with vegetation (photos 1 – 9). There is no evidence that the ash ponds are lined (synthetic or natural) or capped.

Photo 1. Ash Pond C.

Photo 2. Ash Pond C.

Photo 3. Ash Pond C.

Photo 4. Ash Pond C.

Photo 5. Transition point from Ash Pond C to Ash Pond B.

Photo 6. Transition point from Ash Pond C to Ash Pond B.

Photo 7. Transition point from Ash Pond B to Ash Pond A.

Photo 8. Ash Pond A.

Photo 9. Ash Pond A.

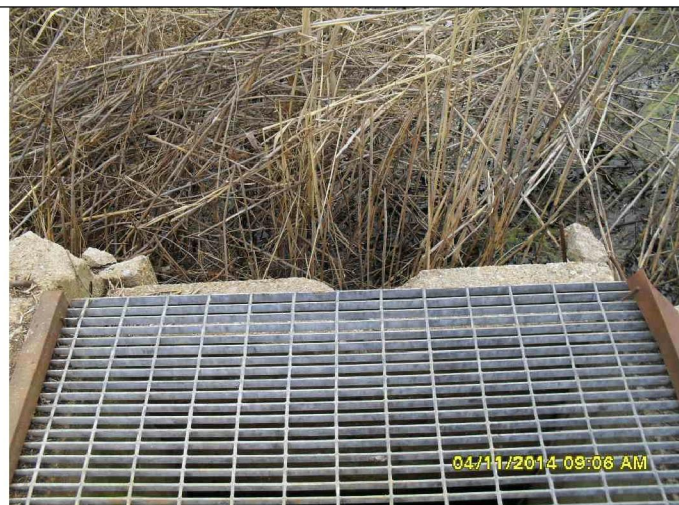
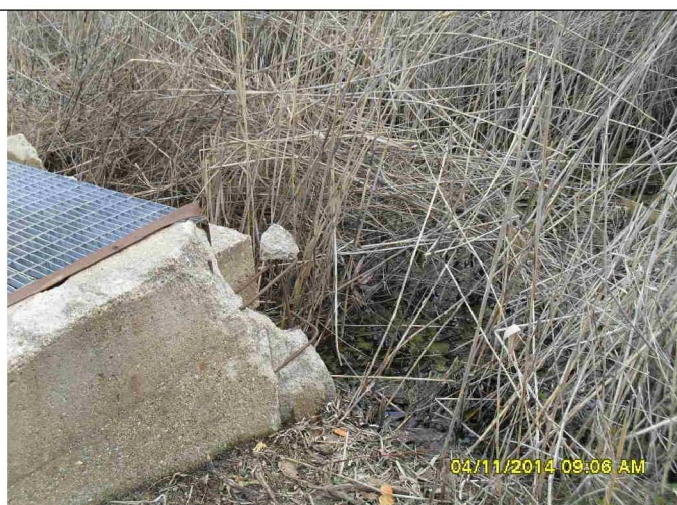
- A discharge weir structure does remain in place at Ash Pond C (photos 10 – 11). The structure at Ash Pond C is draining and/or seeping through a gap in the wall at approximately thirty-five inches below the top as measured by Dominion staff. Flow is estimated at approximately two gallons per minute (photo 12). The discharge is directly to Quantico Creek (photos 13 – 14) and is tidally influenced.

Photo 10. Discharge structure at Ash Pond C.

Photo 11. Discharge structure at Ash Pond C.

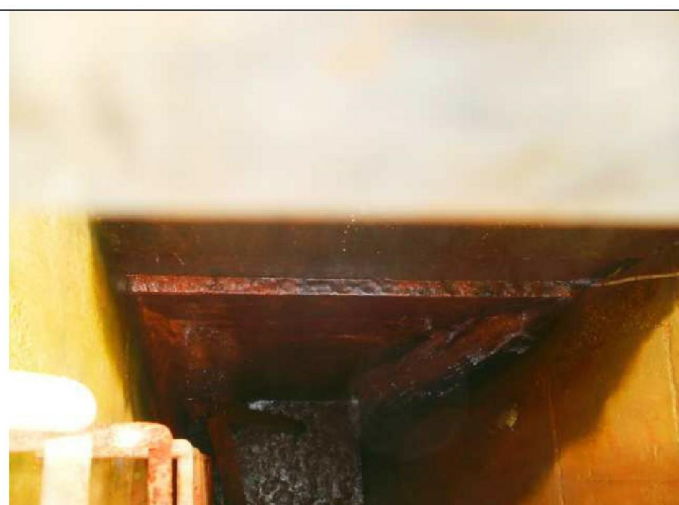
Photo 12. Flow into discharge structure at Ash Pond C.

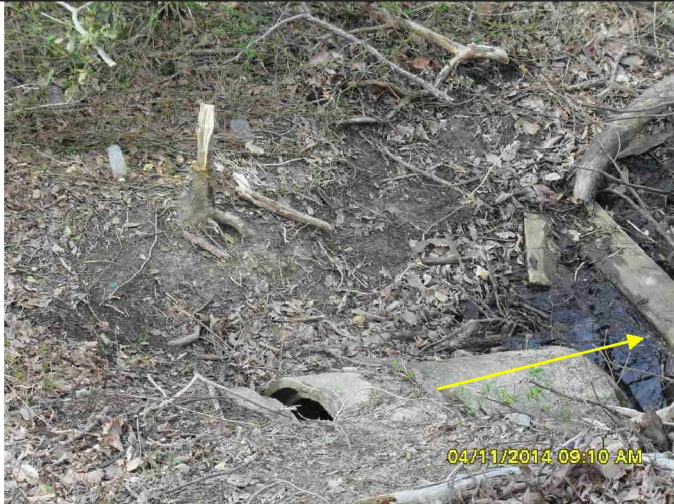
Photo 13. Discharge pipe associated with Ash Pond C. Flow is in the direction of the arrow.

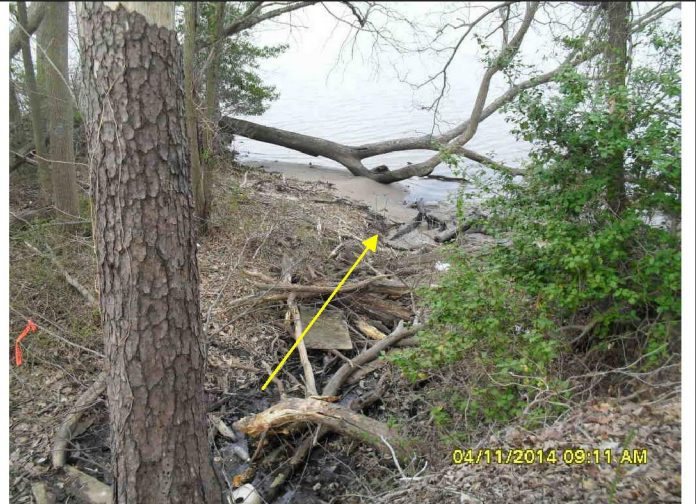
Photo 14. Discharge path from pipe in photo 13 to Quantico Creek. Flow is in the direction of the arrow.

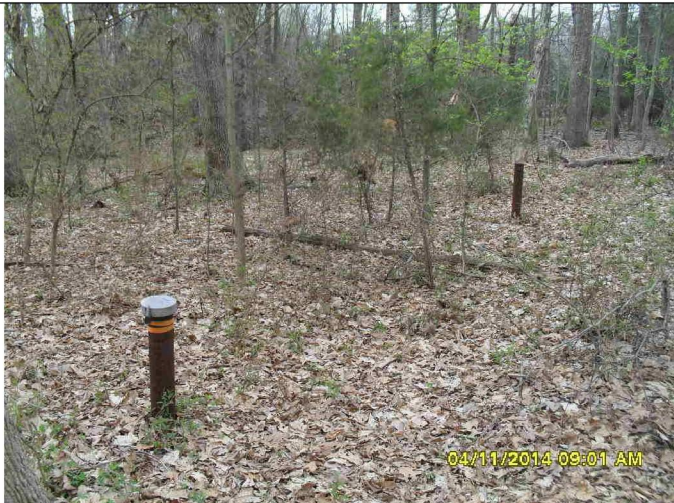
- Two groundwater monitoring wells are located just off the access road in to the ash pond complex in closest proximity to Ash Pond C (photo 15).
- The berm wall for Ash Ponds A, B, and C is one continuous wall (photo 16). There is a downward slope towards Quantico Creek (photo 17). The toe of the path that serves as the berm appears to have seepage along all three ash ponds.

Photo 15. Groundwater monitoring wells located in proximity to Ash Pond C.

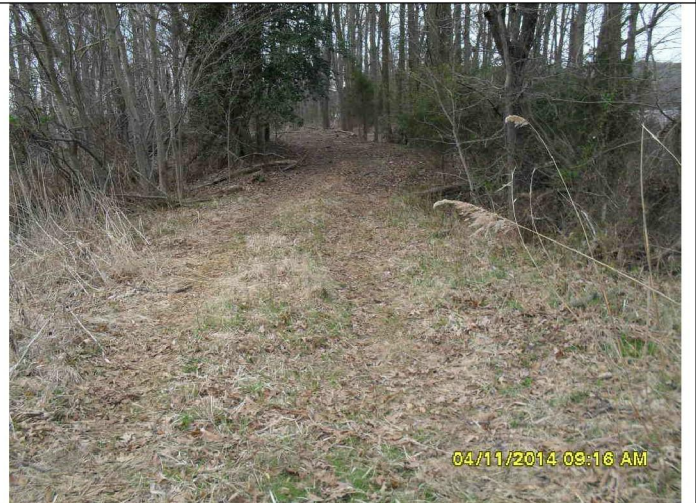
Photo 16. Berm wall.

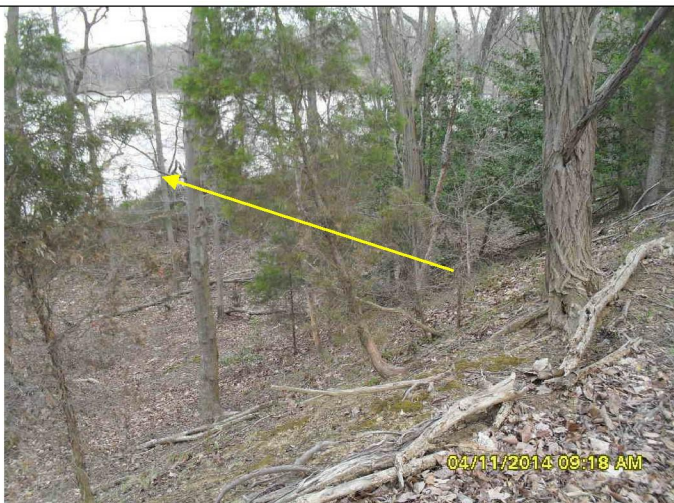
Photo 17. Down slope of berm wall. Quantico Creek is in the direction of the arrow.

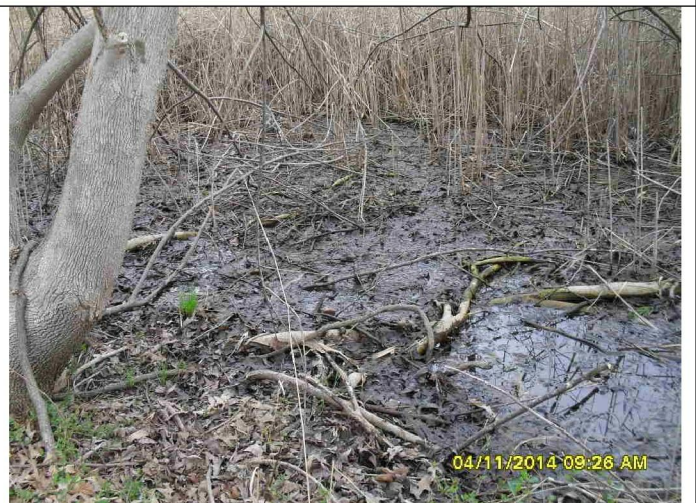
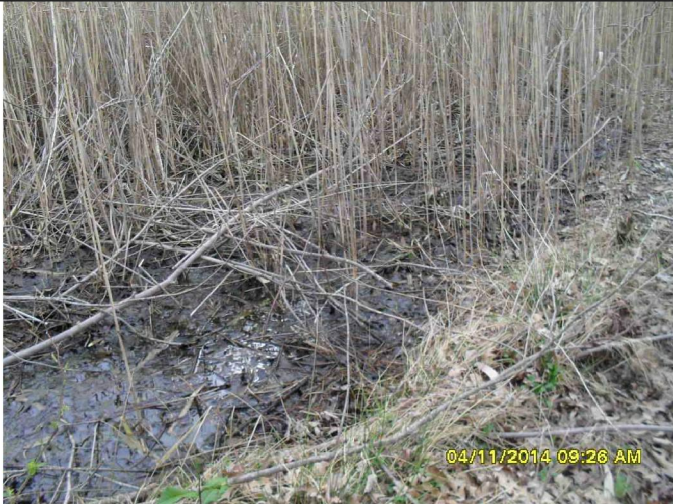
- There is an intermittent overflow point from Ash Pond B (photos 18 – 19). Heavy rains cause this area to overtop the berm wall and drain down the berm slope towards Quantico Creek (photo 20). Standing water in this area appeared dark in color.

Photo 18. Overflow point from Ash Pond B.

Photo 19. Overflow point from Ash Pond B.

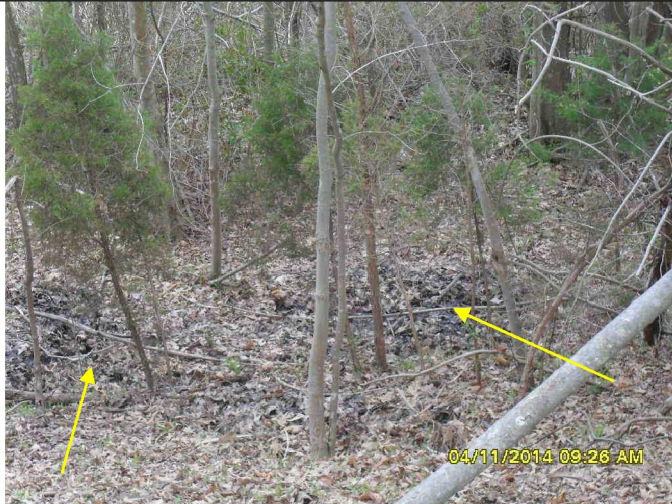
Photo 20. Overflow point from Ash Pond B reaching downward slope towards Quantico Creek.

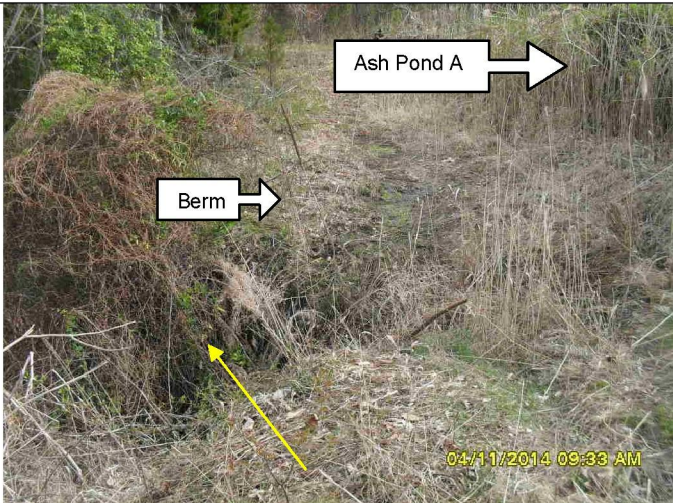
Dominion also noted a breach of the berm associated with Ash Pond A. Dominion believes storm water has collected along the berm causing the storm water to overtop the berm. An area approximately five feet wide by six feet deep has been eroded. It is Dominion's belief that this has been occurring for some time.

- The breach area identified at Ash Pond A (photo 21) appeared to have some vegetation and did not appear to be new. Staff estimates this area to be possibly six to nine months old. Dominion noted a constant flow since the breach was first discovered in March 2014. The flow appeared to be a combination of surface drainage (photos 22 - 24) and seepage through the berm. There did not appear to be erosion at the low flow observed. However, during rain events it does appear that there is potential for severe erosion from water running over the berm. The discharge would flow across a heavily vegetated area prior to any discharge to Quantico Creek (photo 25). Samples have not been collected from this point.

Photo 21. The arrow points to the location of the breach associated with Ash Pond A.

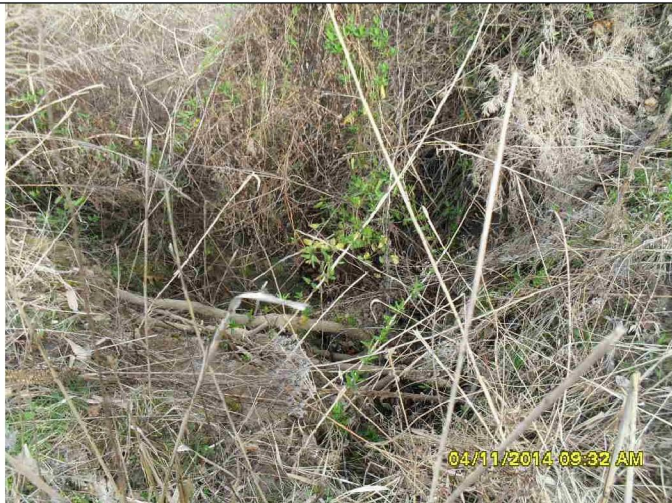
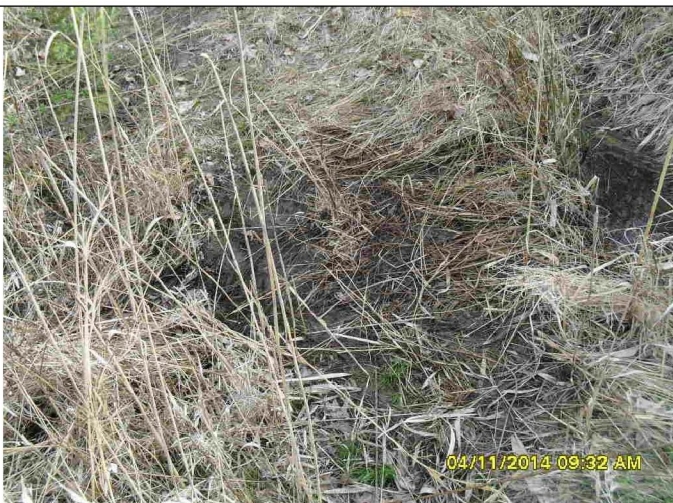
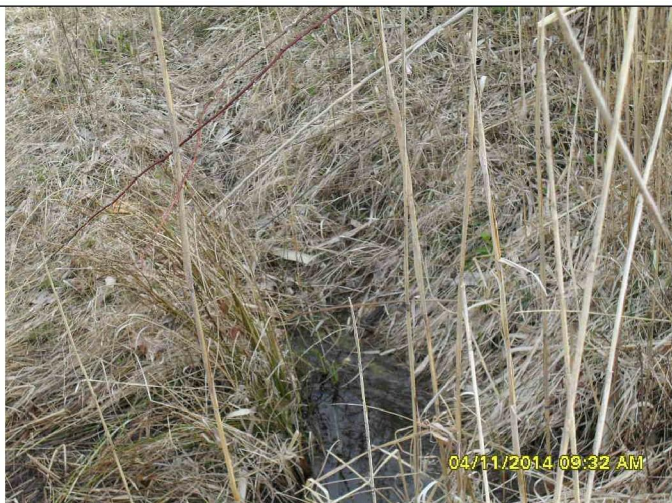
Photo 22. Surface drainage to breach.

Photo 23. Surface drainage to breach.

Photo 24. Surface drainage to breach.

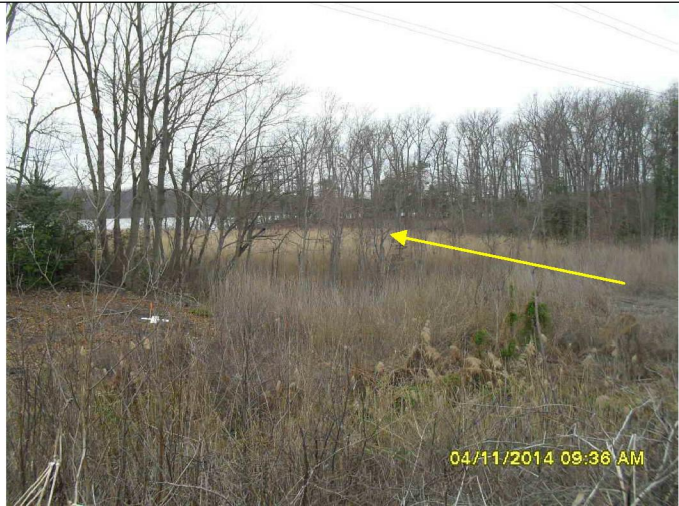
Photo 25. Flow from breach area would travel in the direction of the arrow towards Quantico Creek.

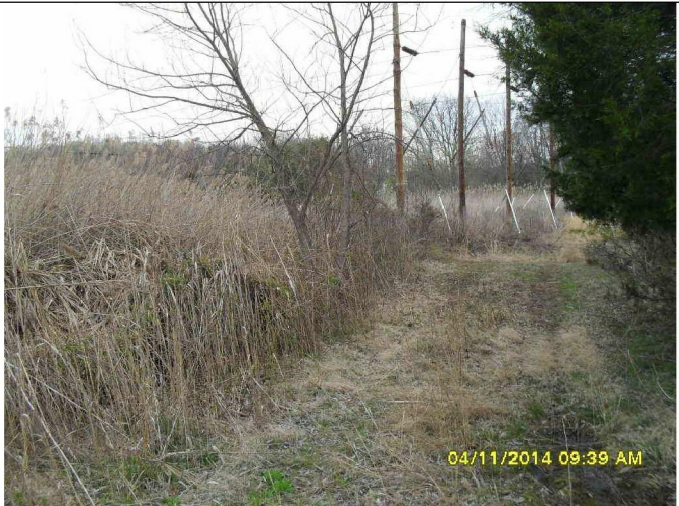
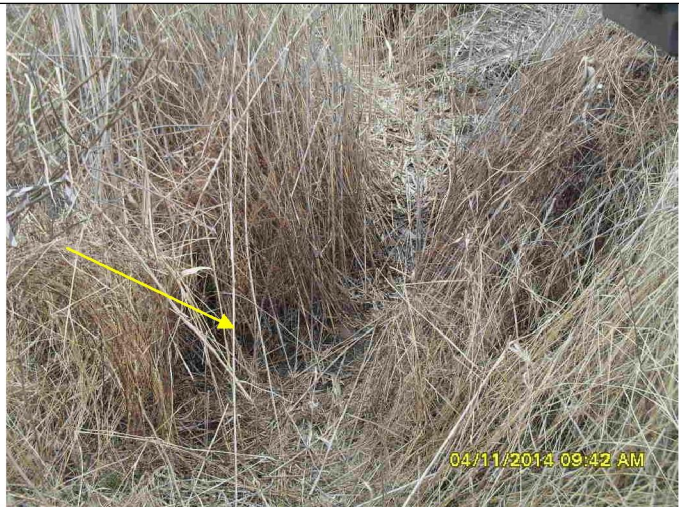
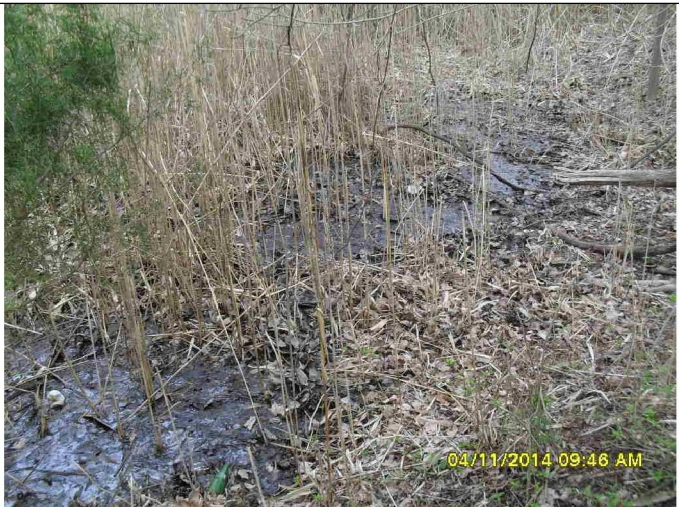
- Ash Pond A has an additional area of flow along the southeastern edge adjacent to the closed sewage treatment lagoons (photos 26 - 28) that may have seepage through the berm.

Photo 26. Southeastern edge of Ash Pond A adjacent to closed sewage treatment lagoons.

Photo 27. Flow noted in area shown in photo 26.

Photo 28. Flow noted in area shown in photo 26.

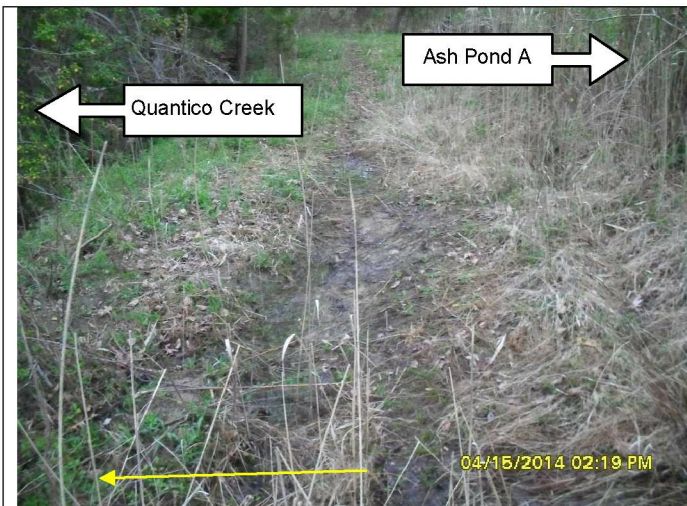
- Weather data for the Possum Point Power Station is obtained from the National Oceanic and Atmospheric Administration (NOAA) station at the Quantico Marine Corps Air Facility. Rainfall data for April 15, 2014, is provided in Attachment 4.
- Rain began falling at approximately 6:00 am on April 15, 2014. Rainfall was heavy at times with approximately one inch being recorded prior to the site visit.
- A visual observation of the breach area identified at Ash Pond A was made. The area appeared to be visually consistent with observations noted during the April 11, 2014, site visit. No water was noted as running over the berm (photo 1). Water collecting at the edge of Ash Pond A was noted as flowing (photo 2).

Photo 1. Berm area adjacent to Ash Pond A. The arrow points to the area of the breach. Note standing water on berm.

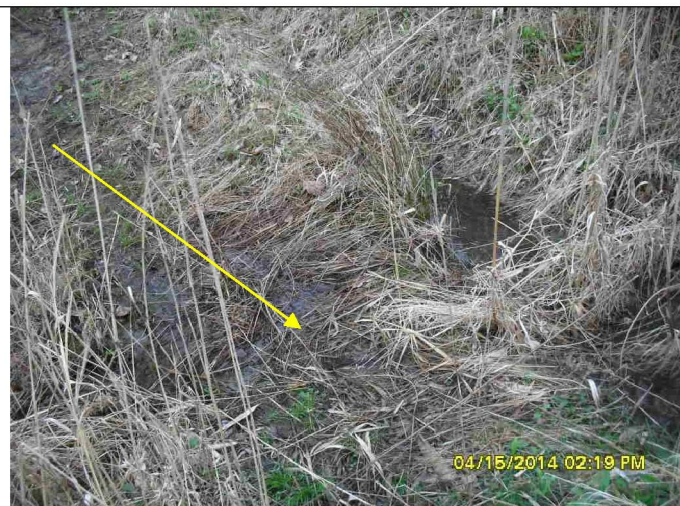
Photo 2. Water collected at the edge of Ash Pond A. Water was flowing in the direction of the arrow.

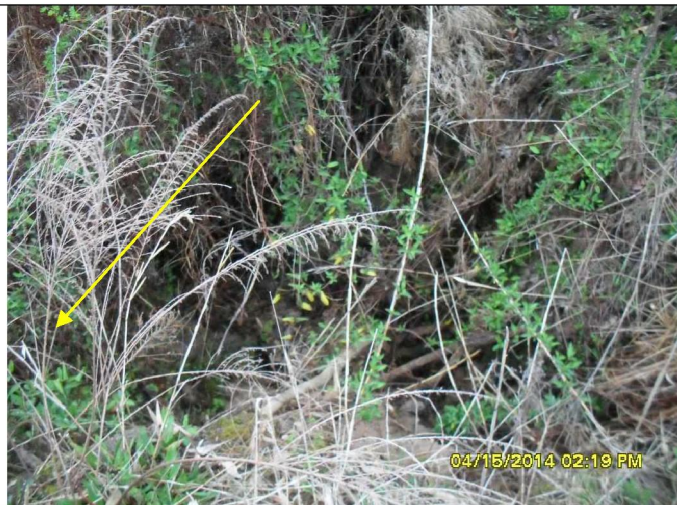
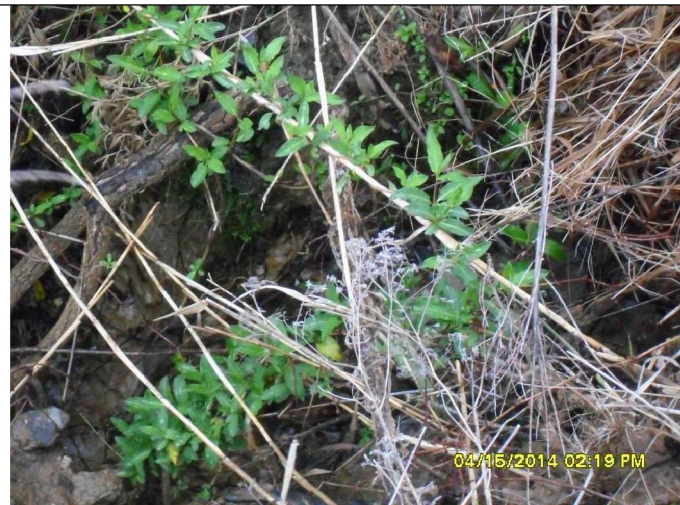
- Flow from the breach area was observed (photos 3 – 4). The flow was distinctly audible, which was not the case during the previous site visit on April 11, 2014.

Photo 3. Breach area of Ash Pond A. Flow from the breach is in the direction of the arrow.

Photo 4. Close up of breach area of Ash Pond A.

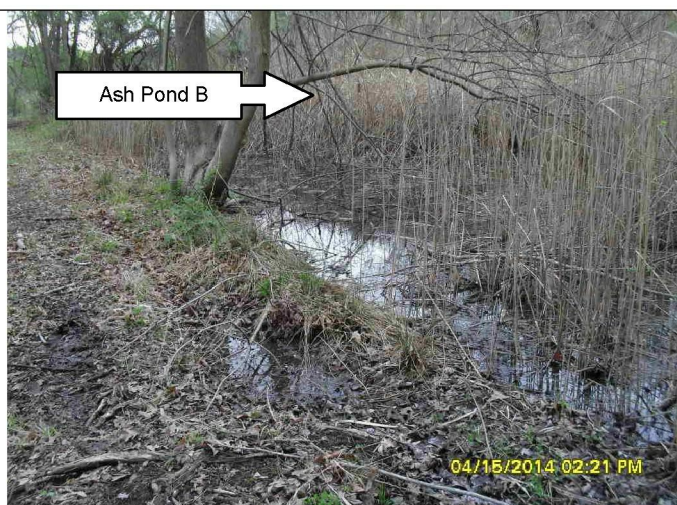
- A visual observation of the suspected overflow point at Ash Pond B was made. The area appeared to be visually consistent with observations noted during the April 11, 2014, site visit. Water was observed collecting at the edge of Ash Pond B (photo 5). No water was observed running over the berm (photos 6 – 7).

Photo 5. Standing water adjacent to Ash Pond B.

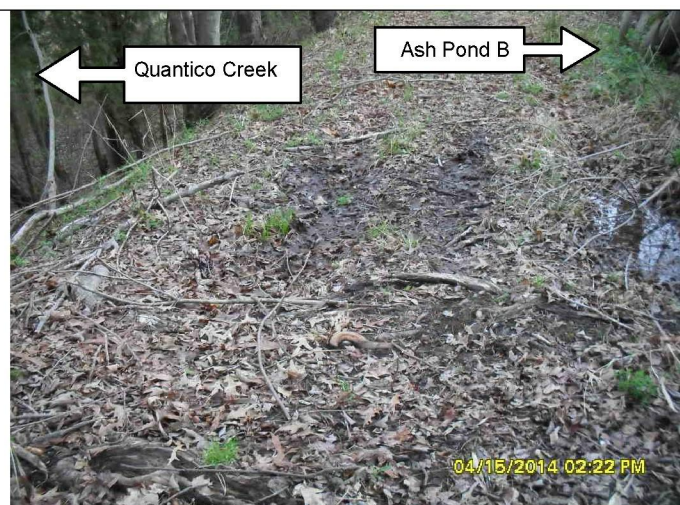
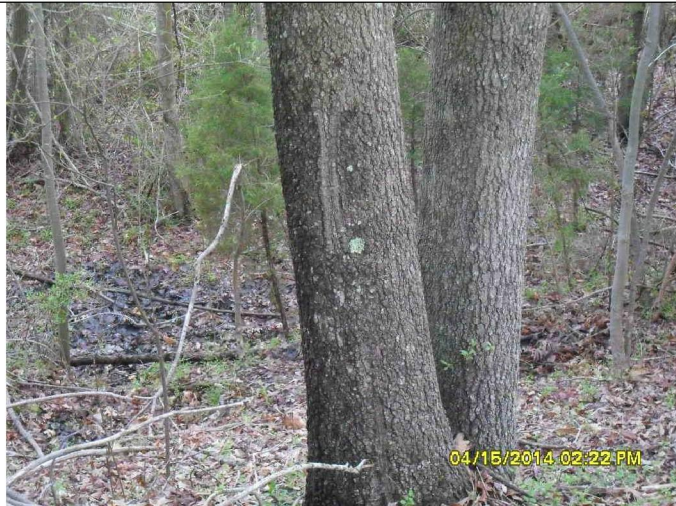
Photo 6. Berm area adjacent to Ash Pond B. Note no water flowing over the berm.

Photo 7. Overflow point from Ash Pond B.
